# Participatory Demonstration of Gully Treatment Method for Gully Rehabilitation in Dollo Schem, Kamba District, South Ethiopia

South Ethiopia Agricultural Research Institute, Arba Minch Agricultural Research Center, Ethiopia

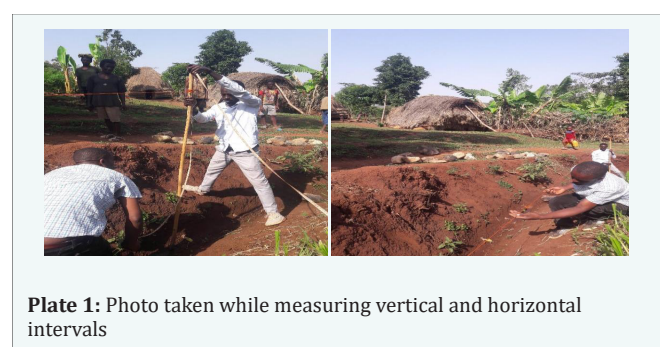
Plate 1: Photo taken while measuring vertical and horizontal intervals

Before rehabilitation, the gullied volume, top and bottom width, slope, vertical and horizontal distance, ground length and depth parameters were taken by measuring from the gullied cross-section field measurement and survey was carried out in 2022. These measurements were averaged to get an estimation of the volume using the following equation:

Key informant interviews were carried out with knowledgeable and influential people at kebele level, such as kebele administrators, Seftnet project focal persons, kebele managers, and development agents, to understand the system and assess the drivers, pressure, extent, impact, response of gully erosion, formation and intervention measures. Secondary data were collected at district and kebele levels from agriculture and project offices (Plate 1).

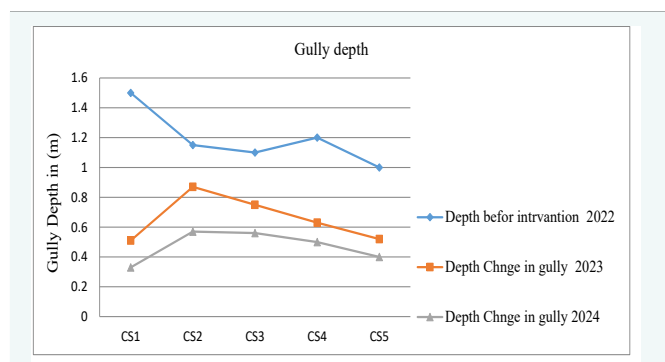
**Figure 3 :** Gully depths before and after intervention

**Depth of Gully:** The depth of gullies was greatly reduced due to implemented rehabilitation measures as time goes on relative to the initial year [Figure 3]. As comparing depth of gully after rehabilitation with the baseline data, it was reduced from 1.15 to 0.656 and 0.473m to consecutive years. Therefore, rehabilitating gullies with check dams integrated with locally available vegetative materials like elephant grass supported by closing the site to regenerate the vegetation cover, leads the deposition of sediment by reducing the runoff velocity and increasing gully bottom roughness where the sediment to be trapped by the structure as well as the vegetation. It indicates that all cross sections, change of gully depth reduction was higher under integrated elephant grass with check dam in consecutive years. Relative to gully depths measured in 2024, the highest percentage reduction of gully depth was observed from all gully cross-section. In line to this study, Kirubel et al. [24], were reported that after 17 years Check-dam-accumulated soil ranges 0.4-1.5m depth and more than 1.5m soil was deposited in the gullies with stone check dams integrated with biological measures at Medego watershed in Tigray, northern Ethiopia.

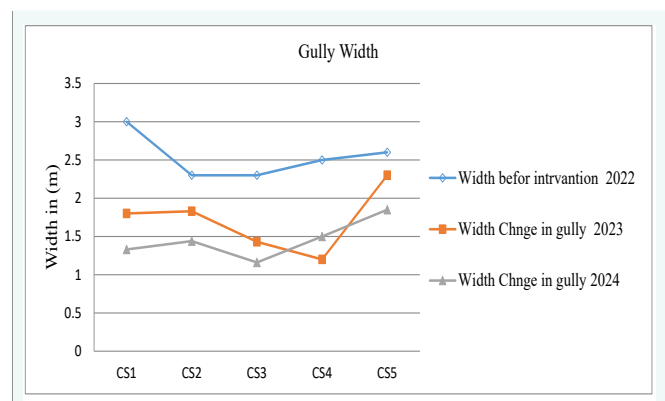
**Figure 4 :** Gully widths before and after intervention

**Gully Width:** The result of the study indicates that, width of gully was changed through time to time due to the implementation of check dam integrated with elephant grass. This indicates the activity of gully changes through the year for the implementation of check dam with elephant grass [Figure 4]. The top width of gully profile was decreased from 2.54m, 1.72m and 1.456m at the end of the experiment followed by the control treatment which increases top width by 1m. The study also indicates, the highest bottom width was recorded from treated gully which increases by 2.54m. This indicates that greater sedimentation with in gully bed while more erosion was from gully bank as width of treated gully increase while depth reduced as time goes on from 2022 to 2024.

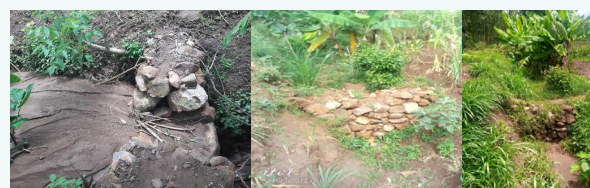
**Plate 4:** Pictures taken sediment deposit behind the check dam

Before rehabilitation the highest soil loss was observed, however after the intervention the lowest soil loss was recorded from stone check dam with elephant grass. The result indicates that amount of soil deposited were increased from time to time. Stone check dam is effective gully rehabilitation methods, as they reduce sediment lost by gullied. Similarly [26], stone check dam constructed in the gully bed reduced the original gully gradient; finally reduce the eroding power of runoff.

Gully treated with elephant grass and stone check dam had deposited 73.1 ton ha<sup>-1</sup> yr<sup>-1</sup> in 2024. This indicates that the implemented integrated gully rehabilitation measures was, to enhanced vegetation cover of the catchment area as well as the gully profile, were effective in trapping the eroded sediment from the catchment area of the respective gully. The result shows that after treated gully bank the highest sediment deposited behind was measured. This is equivalent to (158.938 kg, in 2015 and 183.608 kg in 2024) with bulk density of 1.14, and 1.082 g/cm<sup>3</sup> in respective years. In the other comparison Cross-Section One (CS1) with 9.6m length compared after two years implementation bank and head protection, shows change in gully average width of 1.8m (equivalent to 210.2 and 248.41kg of soil with a bulk density of 1.24 and 1.16g/cm<sup>3</sup>) in Table 3. As observed in the filed monitoring and repeated pictures, the control measure was efficient in trapping sediment and free drainage of surface flow (Plate 4). Similar results were reported in the Debre-Mawi watershed that, the implementation of rehabilitation techniques can reduce downstream sediment concentration [27].
