MRI-Induced Burns from ECG Leads:
Thermal or Electrical Burns?

Burns and Plastic Surgery Unit, Nottingham University Hospitals NHS Trust, UK

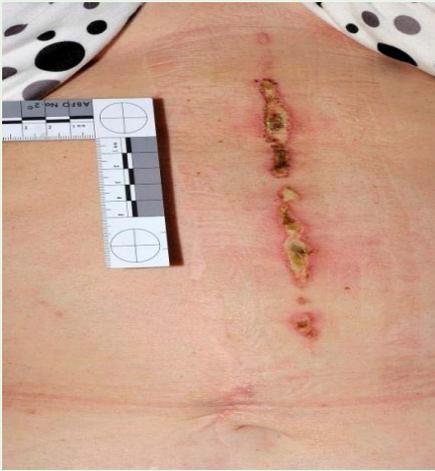
On emergence from the anesthetic, the patient started complaining of a burning sensation on her anterior chest and abdominal wall. On further examination, there was an erythematous, blistering line radiating from the xyphoid process to a few centimeters above the umbilicus, approximately 1cm in width (Figure 1). The line and pattern corresponded to a burn from a braided 3-lead ECG.

Figure 1: An erythematous, blistering line radiating from the xyphoid process to a few centimeters above the umbilicus, approximately 1cm in width.

Cold swabs were immediately applied to the burnt area, analgesia, and 500 IUs booster dose of human immunoglobulins for tetanus were given. The patient was then transferred to our burns unit. She sustained 0.2% superficial partial thickness burn of her Total Body Surface Area (TBSA). She remained hemodynamically stable and afebrile. Laboratory investigations revealed hemoglobin 12g/dL, white cell count $13 \times 10^9/L$, neutrophils 8.3, platelets $849 \times 10^9/L$, sodium 137mmol/L, potassium 4.6mmol/L, Urea 9.7mmol/L and creatinine 135mmol/L. ECG and other investigations, including urine myoglobinuria, were all unremarkable. Urgent plain abdominal radiograph and abdominal ultrasound were ordered, both of which excluded intra-abdominal visceral injury that may have occurred from old metallic surgical clips. The patient was therefore treated conservatively with Urgotul[®] SSD dressing and gauze. She appeared to be clinically dehydrated and was subsequently prescribed 1litre of Hartmann's solution over 4 hours, followed by 1litre over 8hours. The patient made an uneventful recovery and was discharged within 24 hours of admission, with one week follow up at the out-patient dressing clinic.

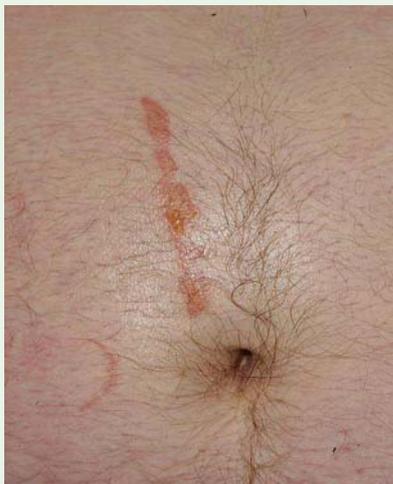
Figure 2: A linear pattern of erythematous and blistered skin measuring approximately eight centimeters long on the anterior abdominal wall.

Total duration of MR scanning lasted 30 minutes. Upon wakening from anesthesia, the patient started to complain of pain around umbilical region. Physical examination revealed a linear pattern of erythematous and blistered skin measuring approximately eight centimeters long on the anterior abdominal wall (Figure 2). Because of our experience with the previous case we suspected that his burns were induced by ECG cables. First aid measures included application of cold swabs and burn injury was treated conservatively with conventional burn dressings.
